ANNUAL REPORT FOR 2014

Bald Creek Site #8 Mitigation Site
Yancey County
TIP No. R-2518B
COE Action ID: SAW-2007-2197-357/300
DWR #: 20071134

Prepared By:
Natural Environment Section & Roadside Environmental Unit
North Carolina Department of Transportation
December 2014

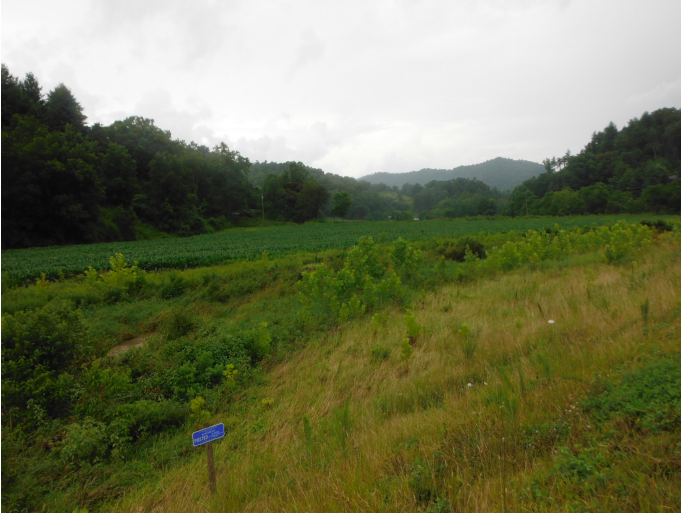
Vegetation Overview Photo

Streambank & Buffer Vegetation: The streambank reforestation was completed in March 2012. The Year 3 vegetation monitoring evaluation noted: Type I: Black Willow, Silky Dogwood and Type II: Sycamore, Green Ash, Tulip Poplar and White Oak were surviving at the time of the monitoring evaluation.
